Oak Bluffs Harbor Oak Bluffs, Massachusetts

US Army Corps of Engineers New England Division

I. Addition out the second	October 1991	Reconnaissan	ce Report
4. TITLE AND SUBTITLE			S. FUNDING NUMBERS
Navigation Improvement S	Study Oak Bluffa	Warbor	
Oak Bluffs, Massachuset	-	1	
oak blulls, massachuset	ts, Recommatssance	Report

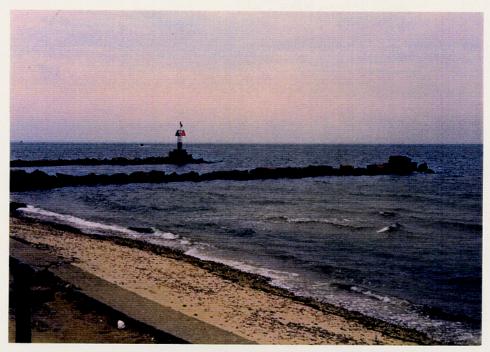
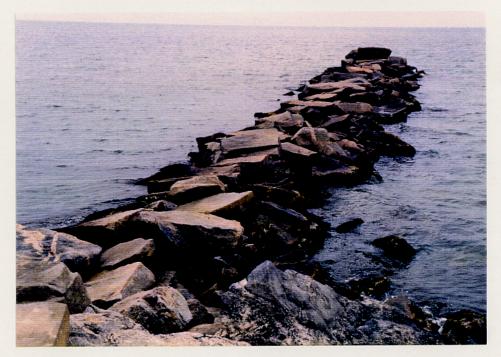
Photographs
Oak Bluffs Harbor
Oak Bluffs, Massachusetts
Figure 2

View of Oaks Bluffs' Harbor Entrance.

View of South Jetty

Local officials predict that within three to five years the north jetty could have deteriorated enough to begin hampering access to the harbor also. Both jetties are in disrepair. Some of the rocks of the north jetty have already fallen out of place. According to the harbormaster, sand drifts through holes and gaps in both jetties and fills in the channel. Neither the town nor the state currently have plans to repair the jetties.

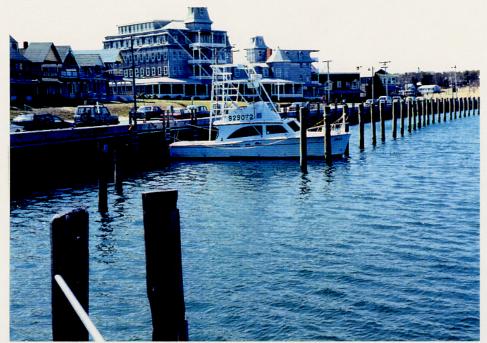
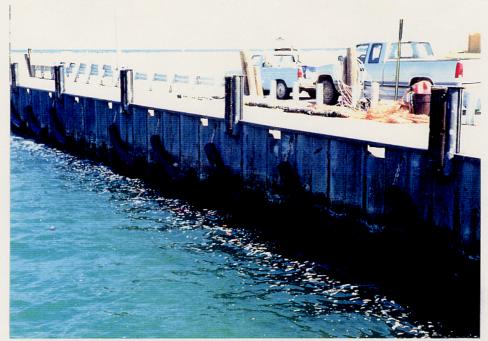
Photographs
Oak Bluffs Harbor
Oak Bluffs, Massachusetts
Figure 3

View of steel sheet pile bulkhead along south side of the harbor.

View of steel and timber sheet pile bulkhead along east side of the harbor.

The present harbor configuration is characterized by numerous bulkheads defining its perimeter (see Figure 3). These bulkheads consist of steel and timber sheet piling. The south side of the harbor contains a steel sheet-pile bulkhead constructed in 1985 along Lake Avenue which is in good condition. The east side of the harbor contains a timber sheet pile bulkhead approximately 500 feet long and a steel sheet pile bulkhead (600 feet long) constructed in 1970 along Circuit Avenue. There is also a
